COAST GUARD RESEARCH AND DEVELOPMENT CENTER GROTON CT  
TRANSITORY FIRE RESISTANCE OF TANKER LIFEBOATS.(U)  
FEB 80 D E BEENE  
CGR/DC-27/79

1. Report No. <b>19 D-19-80</b>	2. Government Accession No. <b>AD-A084257</b>	3. Recipient's Catalog No.	
4. Title and Subtitle <b>Transitory Fire Resistance of Tanker Lifeboats</b>		5. Report Date <b>February 1980</b>	6. Performing Organization Code

7. Author(s) <b>David E. Beene, Jr.</b>		8. Performing Organization Report No. <b>R&amp;DC 27/79</b>	
9. Performing Organization Name and Address <b>United States Coast Guard Research and Development Center Avery Point Groton, Connecticut 06340</b>		10. Work Unit No. (TRAIS)

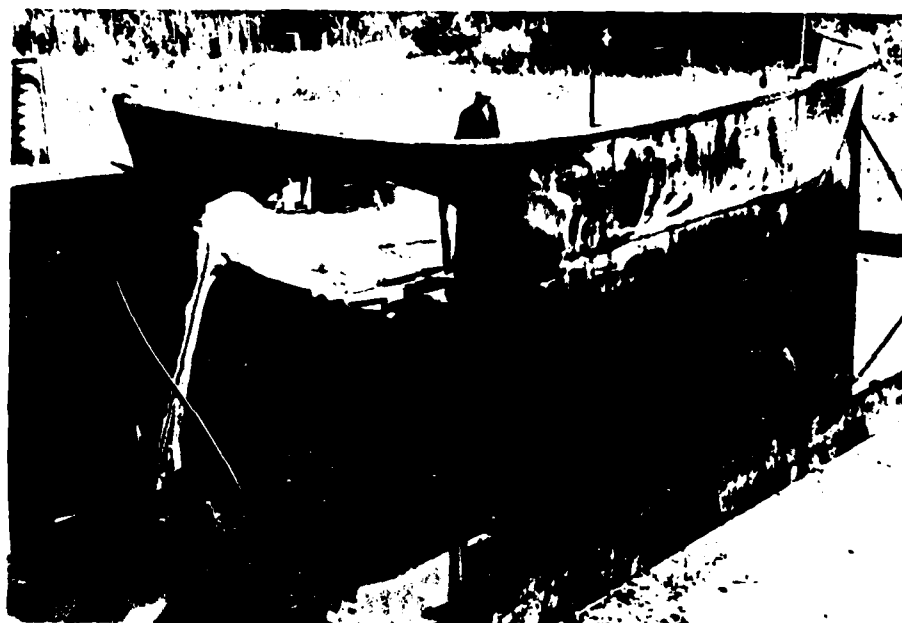
Figure 3  
Aluminum Lifeboat Failure

The lifeboat was constructed of 6061 aluminum alloy in the T6 heat treated condition. Its hull was 0.09 inches (0.23 cm) thick.<sup>2</sup> Fifty seconds into the one-minute test fire an 18 square foot (1.67 sq m) section of

the hull melted and collapsed. At the conclusion of the one-minute test, twenty percent of the hull had melted (Figure 3). At the end of the two-minute test, the entire hull had melted. Only the keel, thwart brackets, and gunwale remained. They were 1.0 inch (2.54 cm), 0.25 inch (0.64 cm) and 0.38 inch (0.95 cm) thick respectively. At the time of the hull failure, the flame temperatures had reached 1560°F (849°C) (Figure 4) and the recorded heat flux was 16 BTUs per square foot per second (Figure 5). At this point, the lifeboat's wooden structures and its fiberglass buoyancy tanks were also aflame. At the conclusion of each test, only the flames in the pen were extinguished. The lifeboat interior and its buoyancy tanks were permitted to burn in order to record length of burning and to determine if they were self-extinguishing. The wooden interior burned itself out six minutes after test pen extinguishment while the foam-filled buoyancy tanks were finally extinguished after twenty-five minutes as they displayed no tendency toward self-extinguishment. The burning foam (rigid polyurethane) in the fiberglass tanks could not be extinguished by dry chemical agents and instead had to be extinguished by using the backup water spray system.

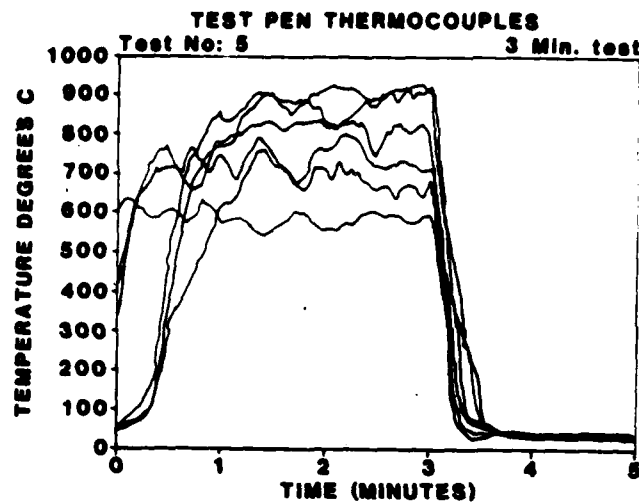
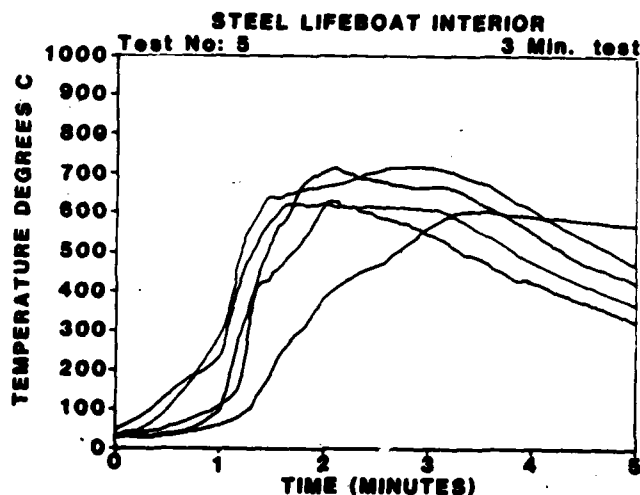
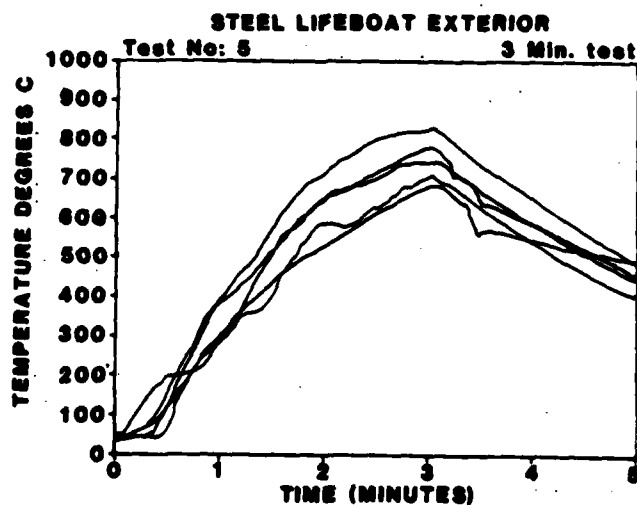
Figure 7

The recorded temperatures of the hull interior were well above the ignition temperatures of untreated wooden structures<sup>6</sup> (Figure 7). In fact, the temperatures of the interior surface of the hull were only slightly lower than the temperature of the exterior of the hull (Figure 7) which was in direct flame contact.

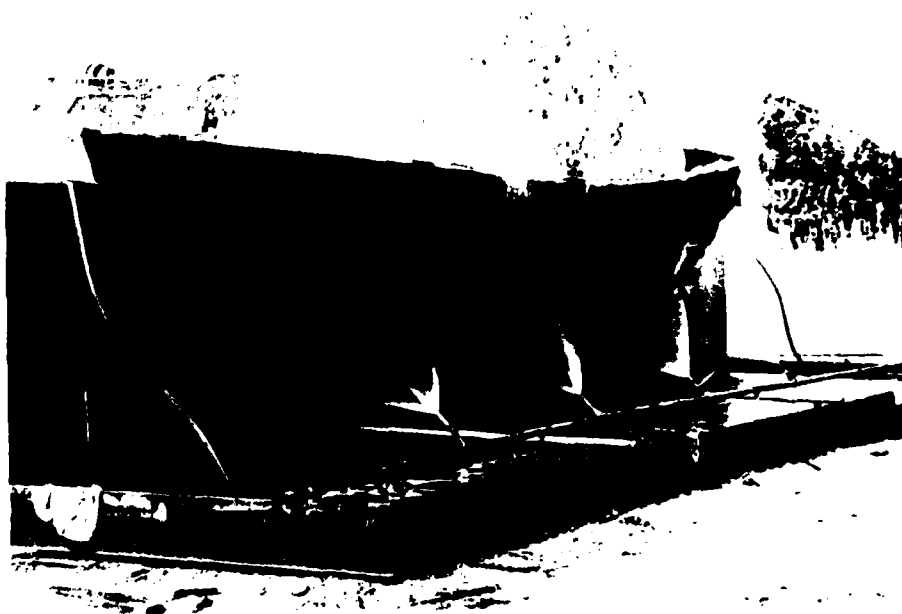
Figure 11  
Water Spray Protection

The water spray was effective in protecting the half-hull lifeboats tested in the 20-minute fires (Figure 11). Two steel and two FRP lifeboats were tested one at a time in the sustained fires. The calculated water spray of 35 gallons per minute (133 liters per minute) delivered approximately 0.23 gallons per minute per square foot (9.37 liters per minute per square meter) across the surface of the hull. Five deluge adjustable spray nozzles were used to disperse the water flow. The nozzles were installed 5 feet (1.5 m) apart on a 2-inch (5.1 cm) diameter water pipe which was installed parallel to and 3 feet (0.9 m) away from the lifeboat inside the test pen. The nozzles were 1 foot (0.3 m) above the test fuel and tilted at a 55° angle so that their spray patterns touched each other as well as the gunwale and the keel.

The FRP hulls were more susceptible to damage than the steel hulls in the long-term fires, especially when a nozzle failed or a spray pattern proved inadequate. For example, in Test Number 12, a nozzle malfunctioned for a few minutes and a 3-foot by 3-foot (0.9 m by 0.9 m) layer of woven roving peeled away from the unprotected hull exterior and collapsed into the test pen. The remaining layers of resin and fiberglass, however, still appeared quite firm and waterproof. In addition, at the conclusion of each of the tests two to three bubbles of woven roving, usually 1 foot (0.3 m) in diameter and 0.5 foot (0.15 m) high, would form on the exteriors of the hull. The hull beneath the bubble, however, still appeared firm and waterproof.

The FRP hulls also proved more vulnerable to damage in flames from adverse winds. In the previously mentioned test, the flames blew around the end of the test pen and completely covered the aft section of the hull. As flames engulfed both sides of the lifeboat, the resin in the hull was almost completely consumed in a 2-foot (0.61 m) diameter circle on the hull. Even though almost void of resin at this point, the layers of woven roving and fiberglass mat still remained. The hull in this area was no longer waterproof. The buoyancy tanks were not damaged in the 20-minute fires.

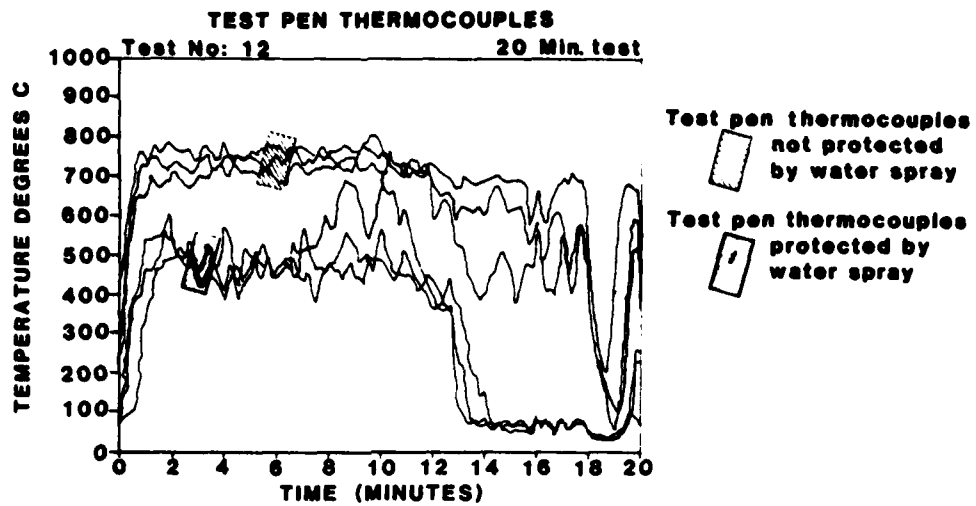
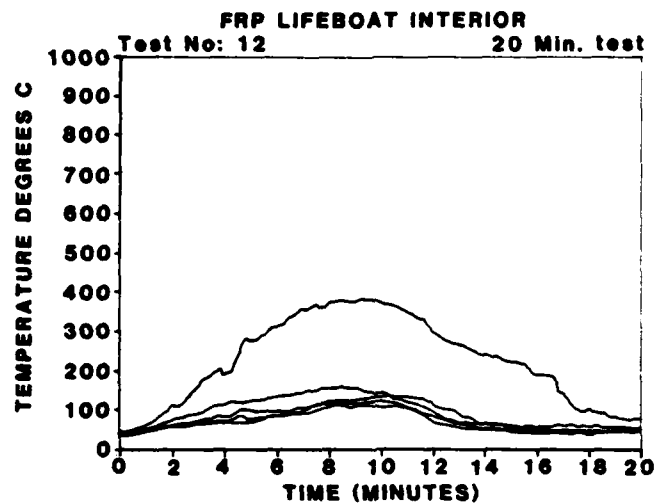
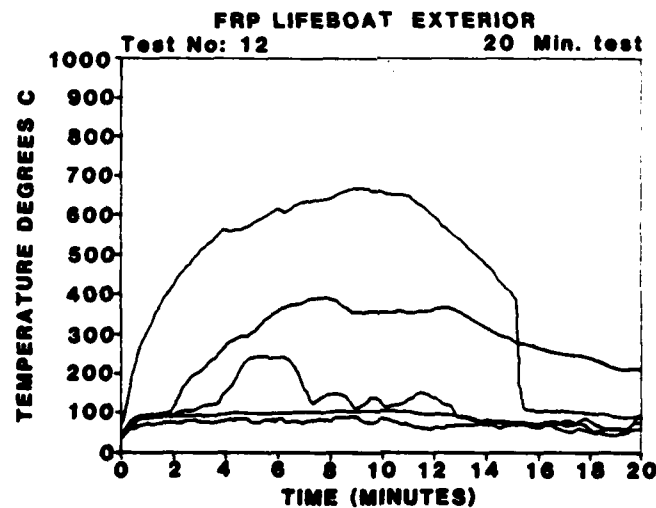
Figure 12

(1) The interior of the FRP hull indicated only a very slight temperature rise, 122°F (50°C), during the 20-minute fire when compared to the 3-minute fire (Figures 12 and 9). Assuming that the temperature increase is slight because of the water spray, the longer test time does provide the interior of the hull an opportunity to seek a thermal equilibrium with the exterior of the hull. It appears that as the outer layer of woven roving chars, its cloth surface acts as a sponge to hold the water spray against the hull surface to help in cooling.

(2) The exterior hull temperatures were noticeably lower, 392°F (200°C), in the 20-minute test than in the 3-minute test (Figures 12 and 9).

(3) The three test pen thermocouples in the water spray just below the hull show a considerably lower temperature, 472°F (300°C), than the three test pen thermocouples which are not protected by the water spray (Figure 12).
